Technical Information
TM 315-12

TWIN ASTIR
TWIN ASTIR
TRAINER

Subject: Replacements of Hotellier Quick-links of the control system.

Effectivity: Glider TWIN ASTIR and TWIN ASTIR TRAINER from serial-number 3000 to 3275 including. Steps 3 and 4 from serial-number 3000 to 3291 including.

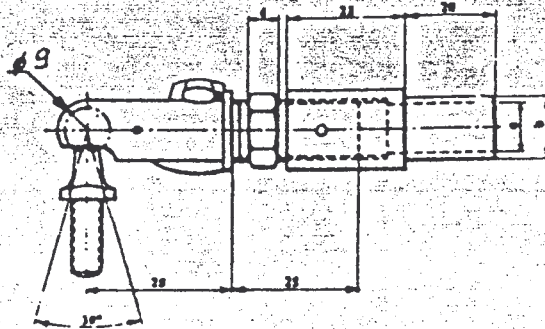
Detail N° 1

Correct
joint with normal
swivel-housing
R 9.41
for elevator

At the elevator ass'y, if not yet installed, the open-housing-type joint R Z 9.41. (detail N^o. 3) will be replaced by a joint R 9.41. (detail N^o. 1) with normal housing. Swivelsize of 9 mm remains unchanged.

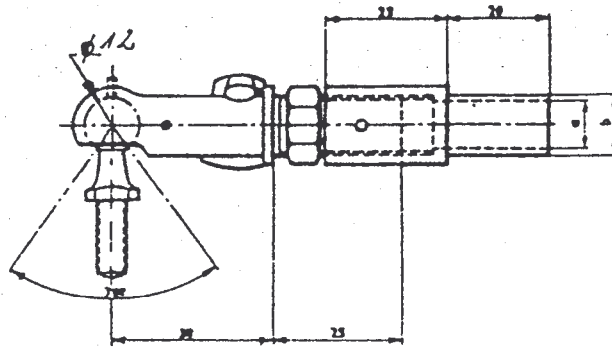
Detail N° 2

Correct
joint with normal
swivel-housing
R 12.41
for aileron

Installed joints R Z 9.41. (open housing) with 9 mm swivel diameter (detail N° 3) of the aileron control ass'y must be replaced by joints R 12.41 (detail N° 2) (normal housing) with 12 mm swivel diameter and installed swivels N° 961 M (detail N° 4) by swivels N° 262 M (detail N° 5).

Note: The installation of stronger links R 12.41. (detail N^o. 2) and swivels N^o.262 M (detail N^o. 5) with a ball-diameter of 12 mm also in the elevator control ass'y is permitted by the aircraft manufacturer.

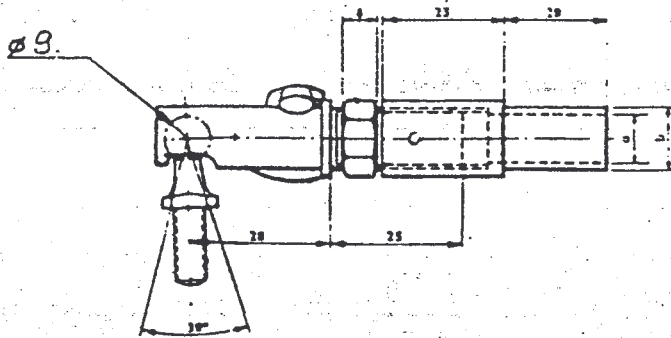
Detail N° 3

Reason: After a high total aircraft time several fractures of 90° quick-connections with open housing (Z-type) due to strong wear and tear were observed at the swivels of the aileron control system which requires the general exchange of the above mentioned joints against those with closed housing and new swivels.

not permitted
joint with open
swivel-housing
(Z-housing)
RZ 9.41.

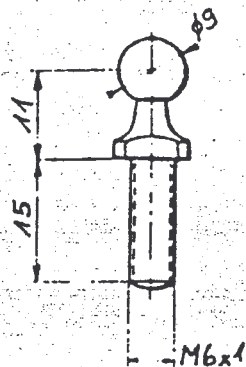
Detail N° 4

Instructions: Step 1. Prior to the next flight and afterwards every 50 hours swivel N° 961 M (detail N° 4) attached to the aileron levers at the root-ribs and the elevator lever must be inspected for wear and tear. Step 1 is not applicable if the elevator push-rod is already equipped with a joint R 9.41. (detail N° 1).

Diameter of the swivel has to be controlled by a micrometer at differences in diameter may not exceed 0.1 mm (0.004 in.) that means the swivel must be spheric.

Tolerances in excess of 0.1 mm (0.004 in.) require step 2 prior to the next flight.

Swivel
N° 961 M
for elevator

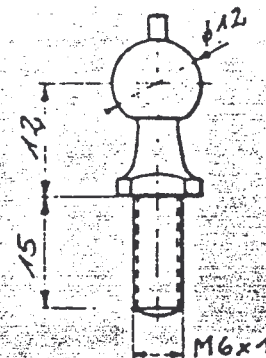
Detail N° 5

Swivel
N° 262 M
for aileron
