Subject: Inspection and reinforcement of welded parts in the flight control system of the gliders GROB G 103 TWIN II and G 103 A TWIN II ACRO. The following welded parts will be reinforced:

Service Bulletin  
TM 315-37

GROB  
G 103 TWIN II  
G 103 A TWIN  
II ACRO

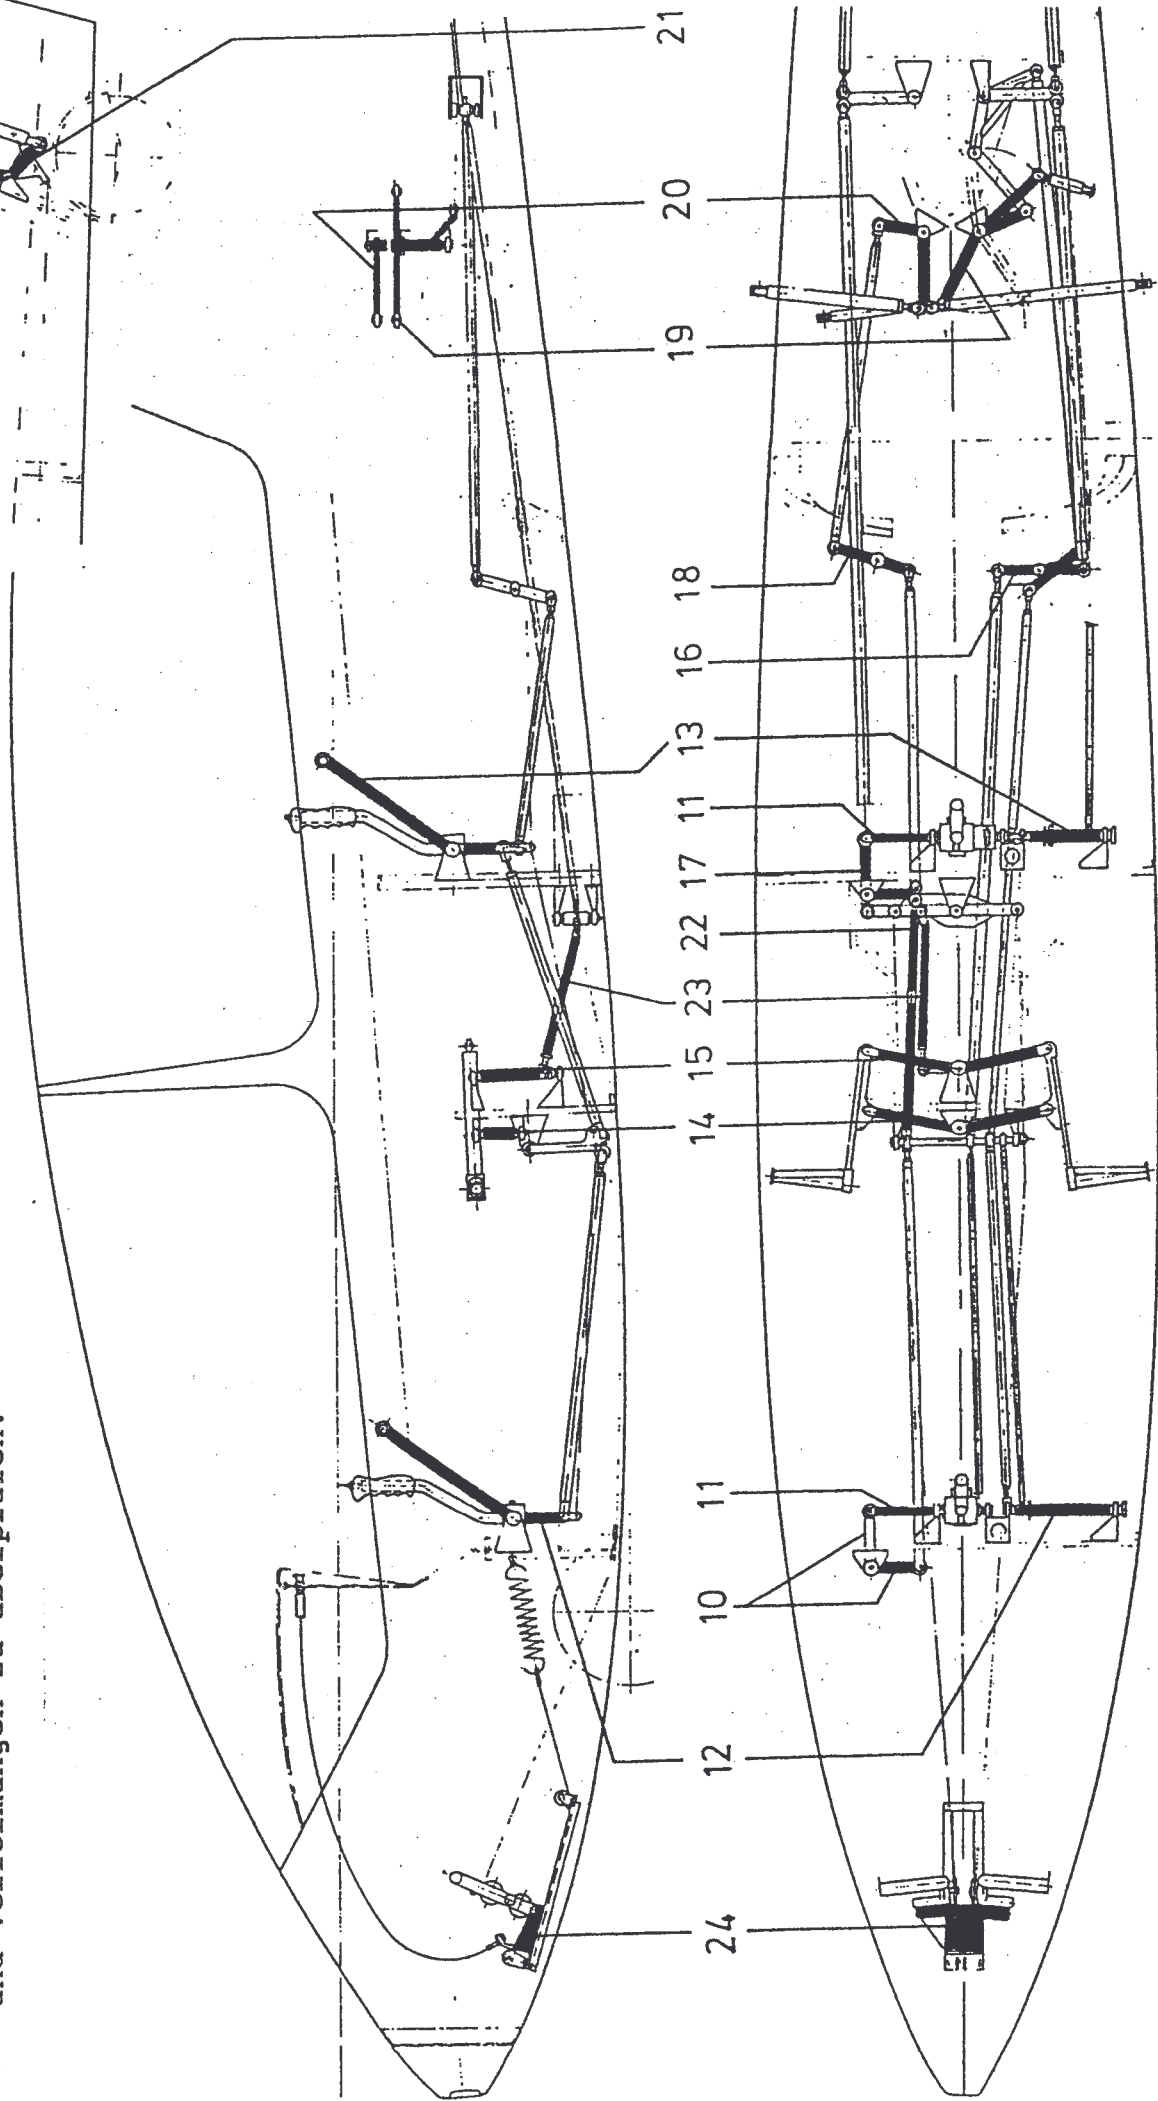
Übersichtsblatt zur Durchführung der Maßnahme 1 von TM 315-37

Die in unten abgebildeter Übersichtszeichnung markierten Steuerungsteile sind im Bereich der Schweißnähte auf Anrisse und Verformungen zu überprüfen.

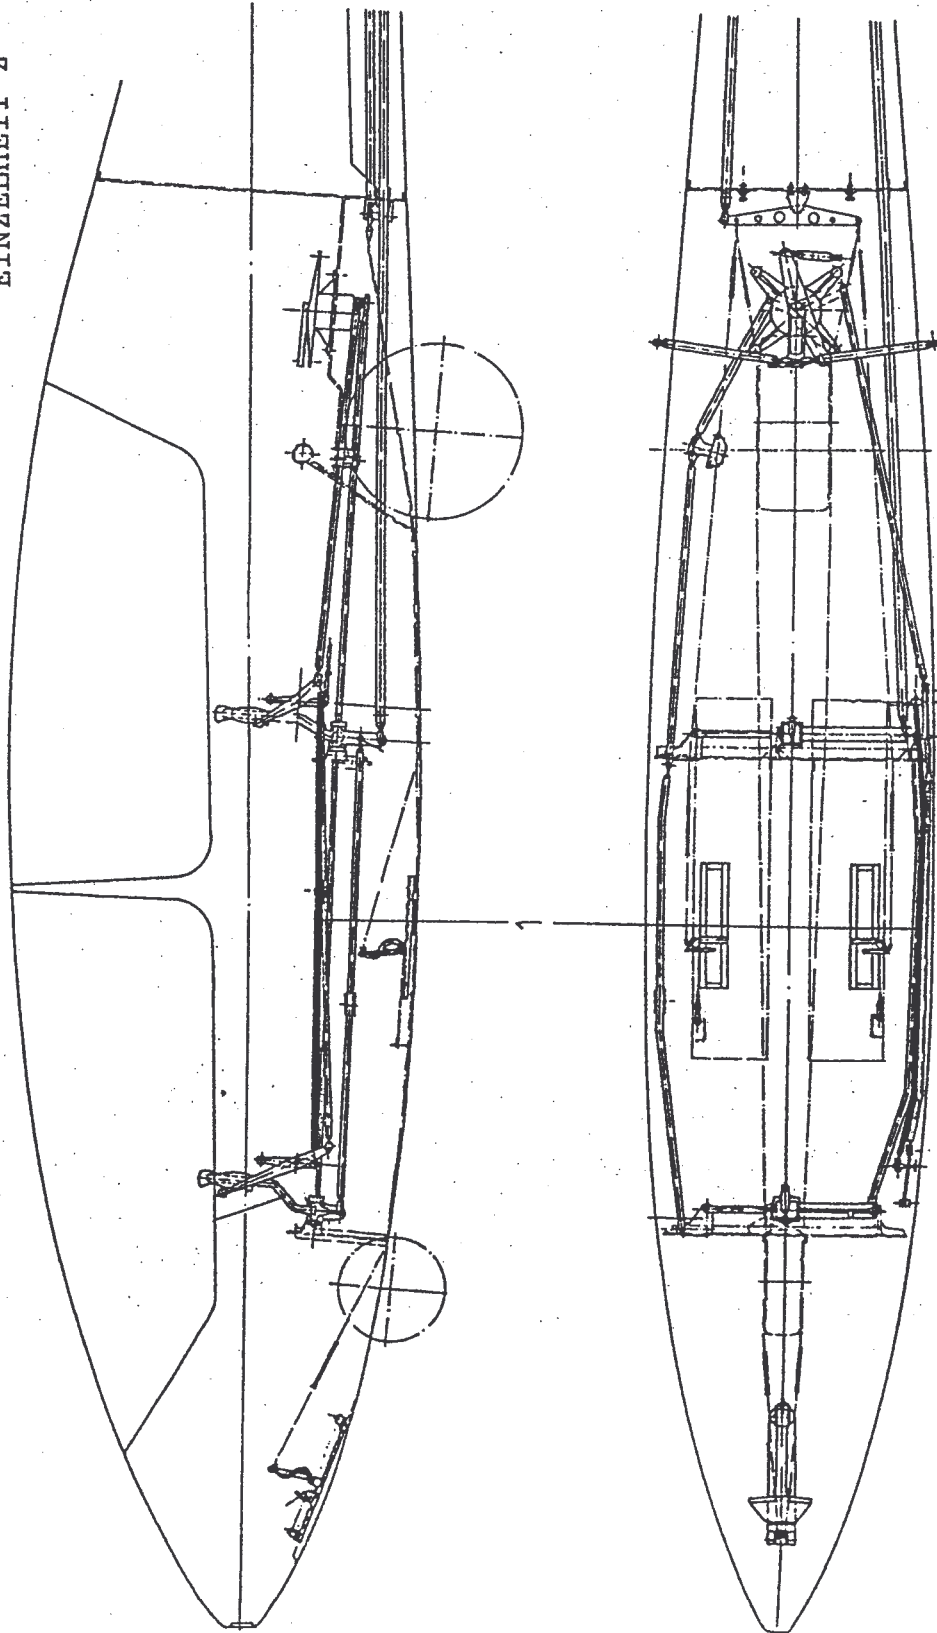
Übersichtsblatt zur Durchführung der Maßnahme 1 von TM 315-37 für Werk-Nr. 3501 - 3729

Die in unten abgebildeter Übersichtszeichnung markierten Steuerungsteile sind auf Anrisse und Verformungen zu überprüfen.
