Subject: Inspection of the correct installation position of the fixing bolts of aileron- and air brake connector at the distributor.

Effectivity: s/n
TWIN ASTIR (incl. Trainer) 3000 - 3291
GROB G 103 "TWIN II" 3501 - 3729
(incl. ACRO)

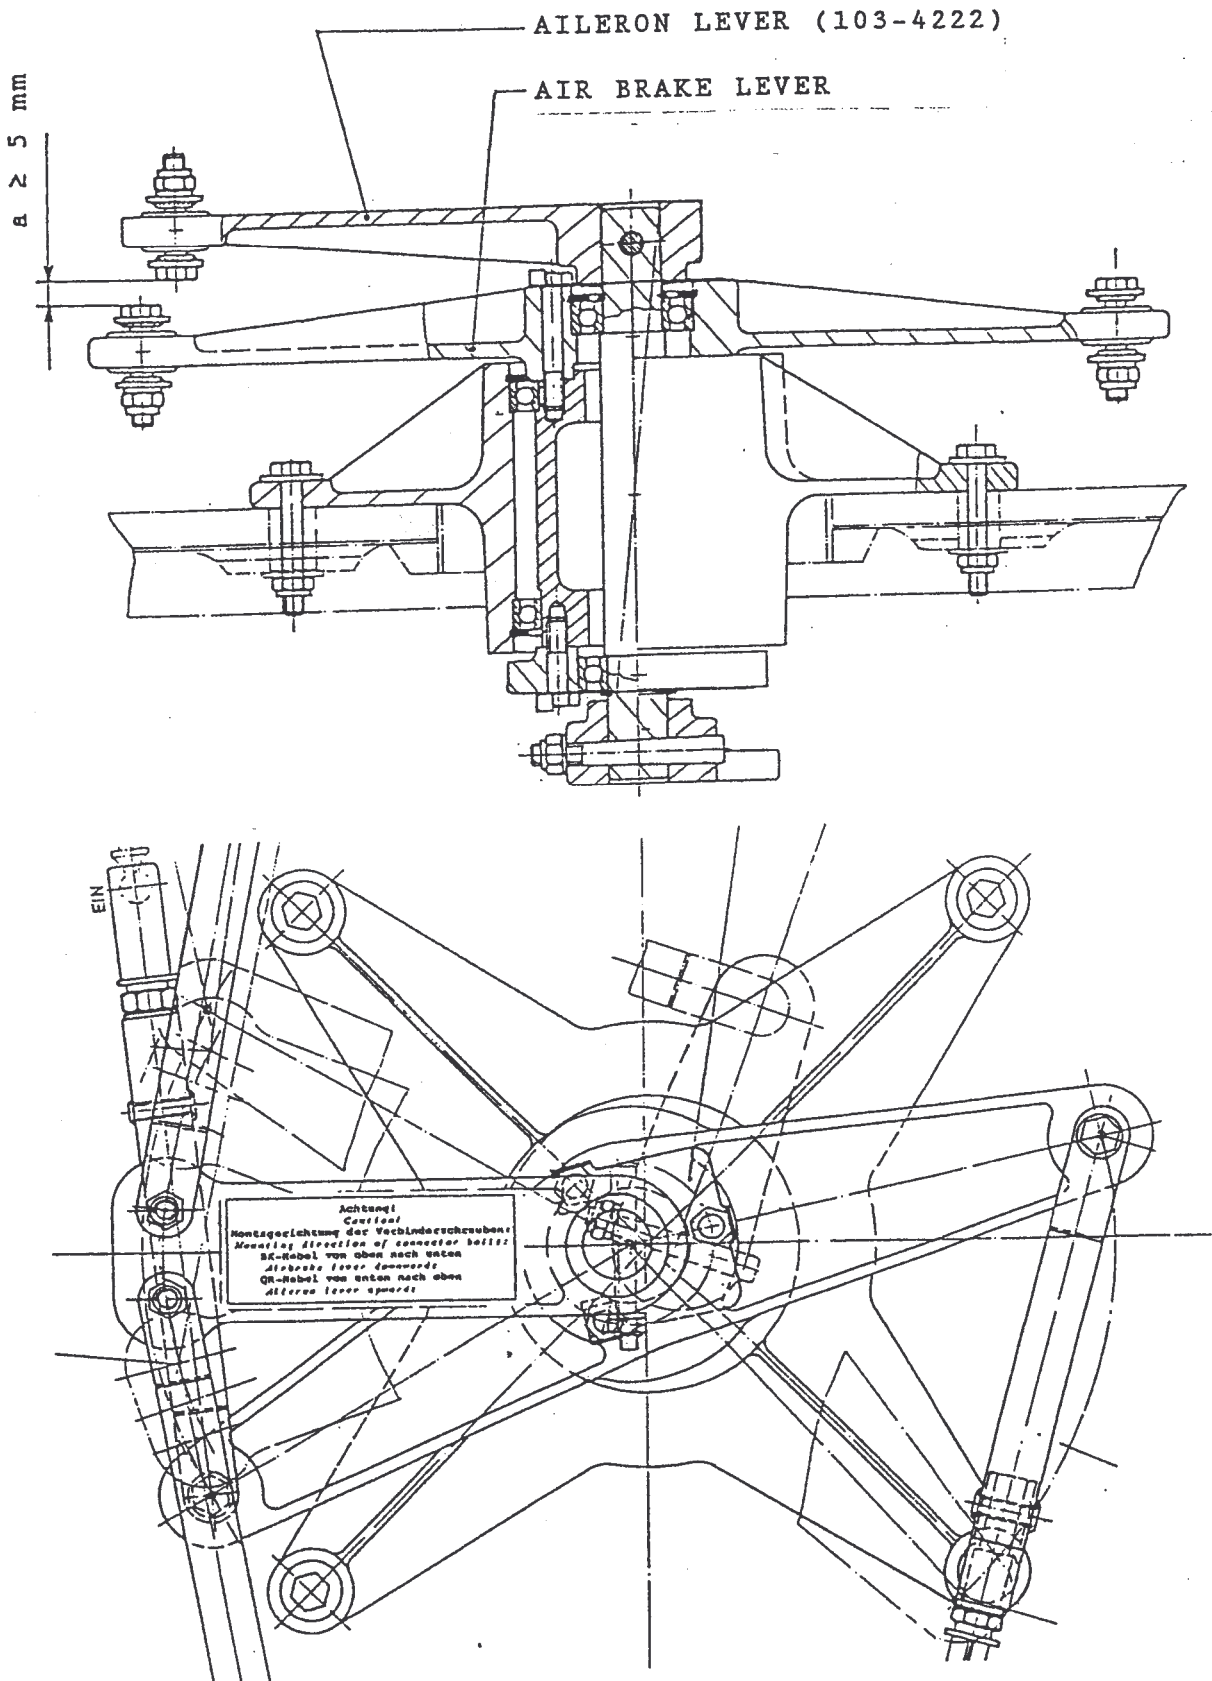
Fig. 1 Aileron- and air brake connector at the distributor

Reason: An accident investigation revealed that the owner of a TWIN ASTIR - probably when performing a service bulletin - mounted the fixing bolts on the aileron connector downwards. The manufacturer specifies installation upwards.

The wrong mounting of the bolts can lead to a reciprocal interference of aileron- and air brake control.

- 1.1 The following mounting direction of the bolts is mandatory:
- on the airbrake lever downwards
 - on the aileron lever upwards

The boltheads must have a minimum distance of $a = 5$ mm to each other.

All bolts that have been incorrectly installed have to be removed and reinstalled observing the correct installation position according to fig. 1 and using new stop nuts.

2.2 Obtaining the minimum distance.
If the required minimum distance of $a = 5 \text{ mm}$ is not obtained, the manufacturer has to be contacted immediately.

3.2 Gluing of the placard (see fig. 1) with glue (e.g. PATTEX).
