Subject: Extension of service life

The Repair Instruction No. 315-45/2 is part of the Service Bulletin TM 315-45 and contains the mandatory replacement of the airbrake-over-centre levers P/N 103-4123/4124 and the installation of inspection holes for TWIN ASTIR and TWIN ASTIR TRAINER during the 3000 hours inspection.

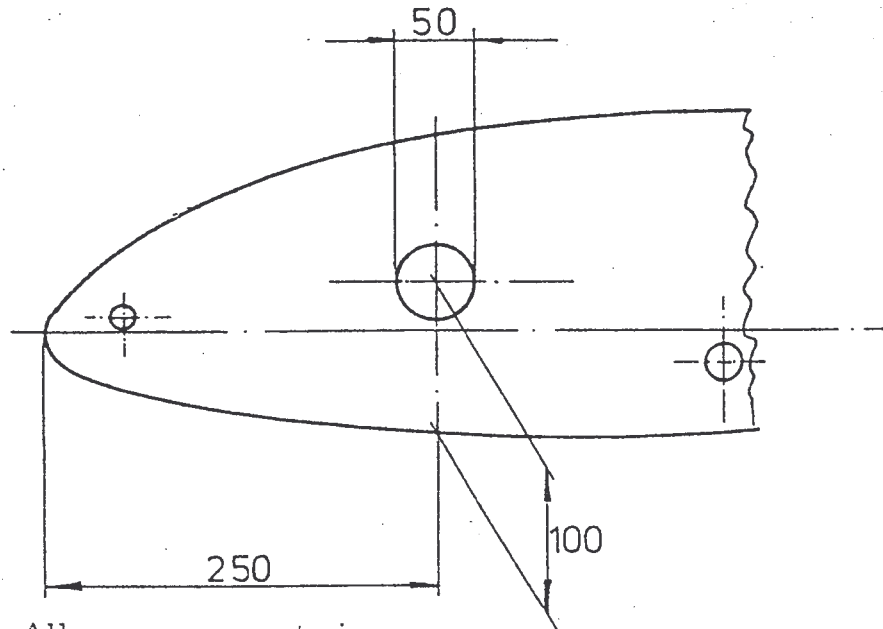
2. Installation of an inspection hole in the root rib, (if Service Bulletin TM 315-15 or TM 315-26 are not performed)

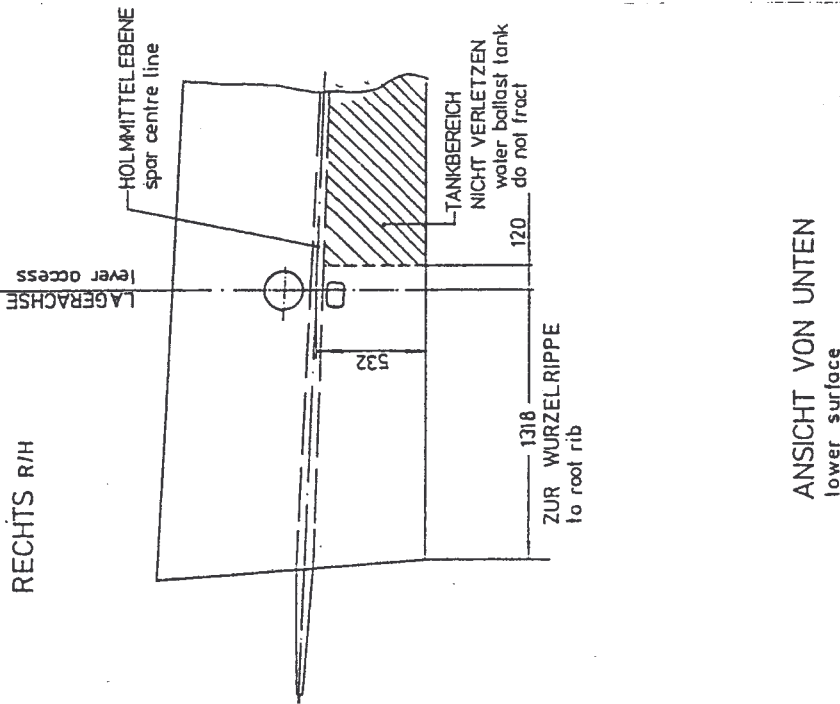
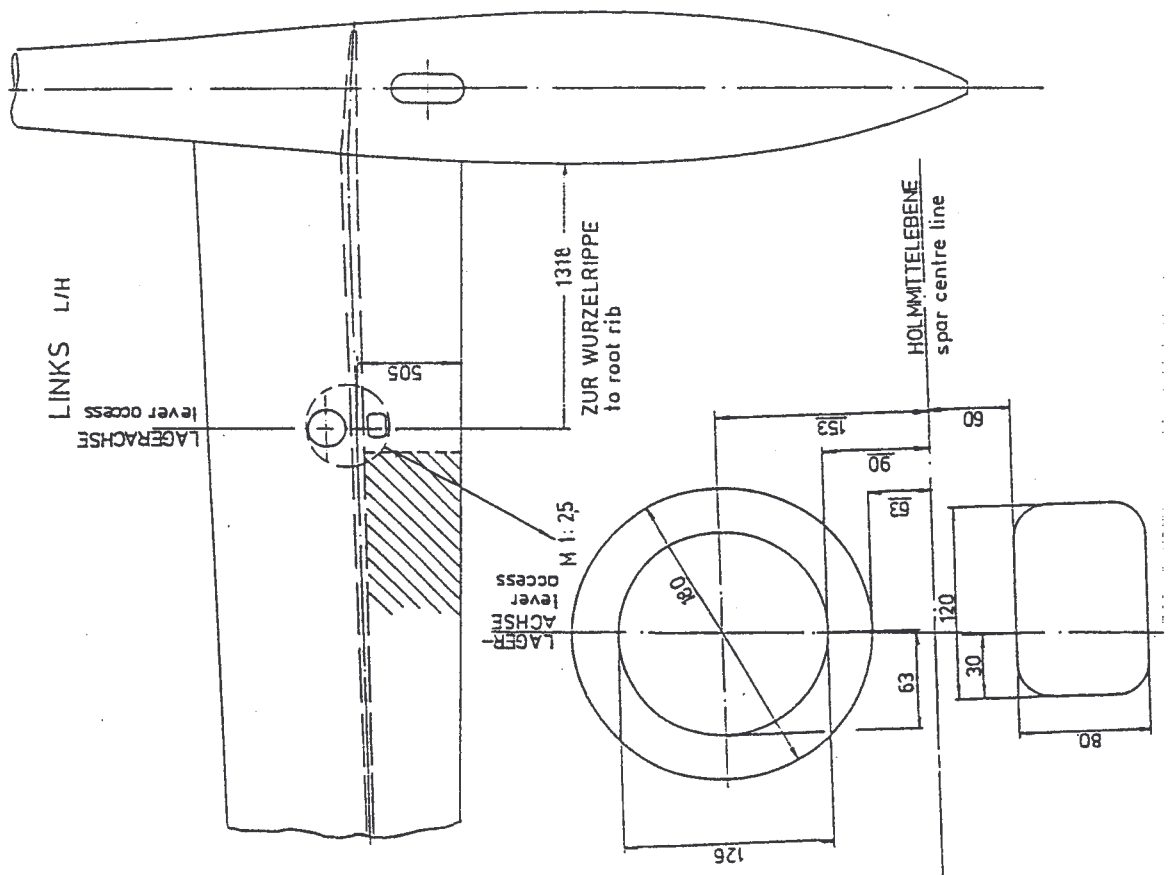
ZEICHNUNG 1
DRAWING 1

Position der Öffnungen
Position of the openings

7. Mark the position of the smaller hole in front of the spar according to drawing 1.

It is important, to ensure that the distance is not less than 60 mm to the spar centre line in accordance to drawings 1 and 2, to prevent damage to the lamination angles in the spar area.

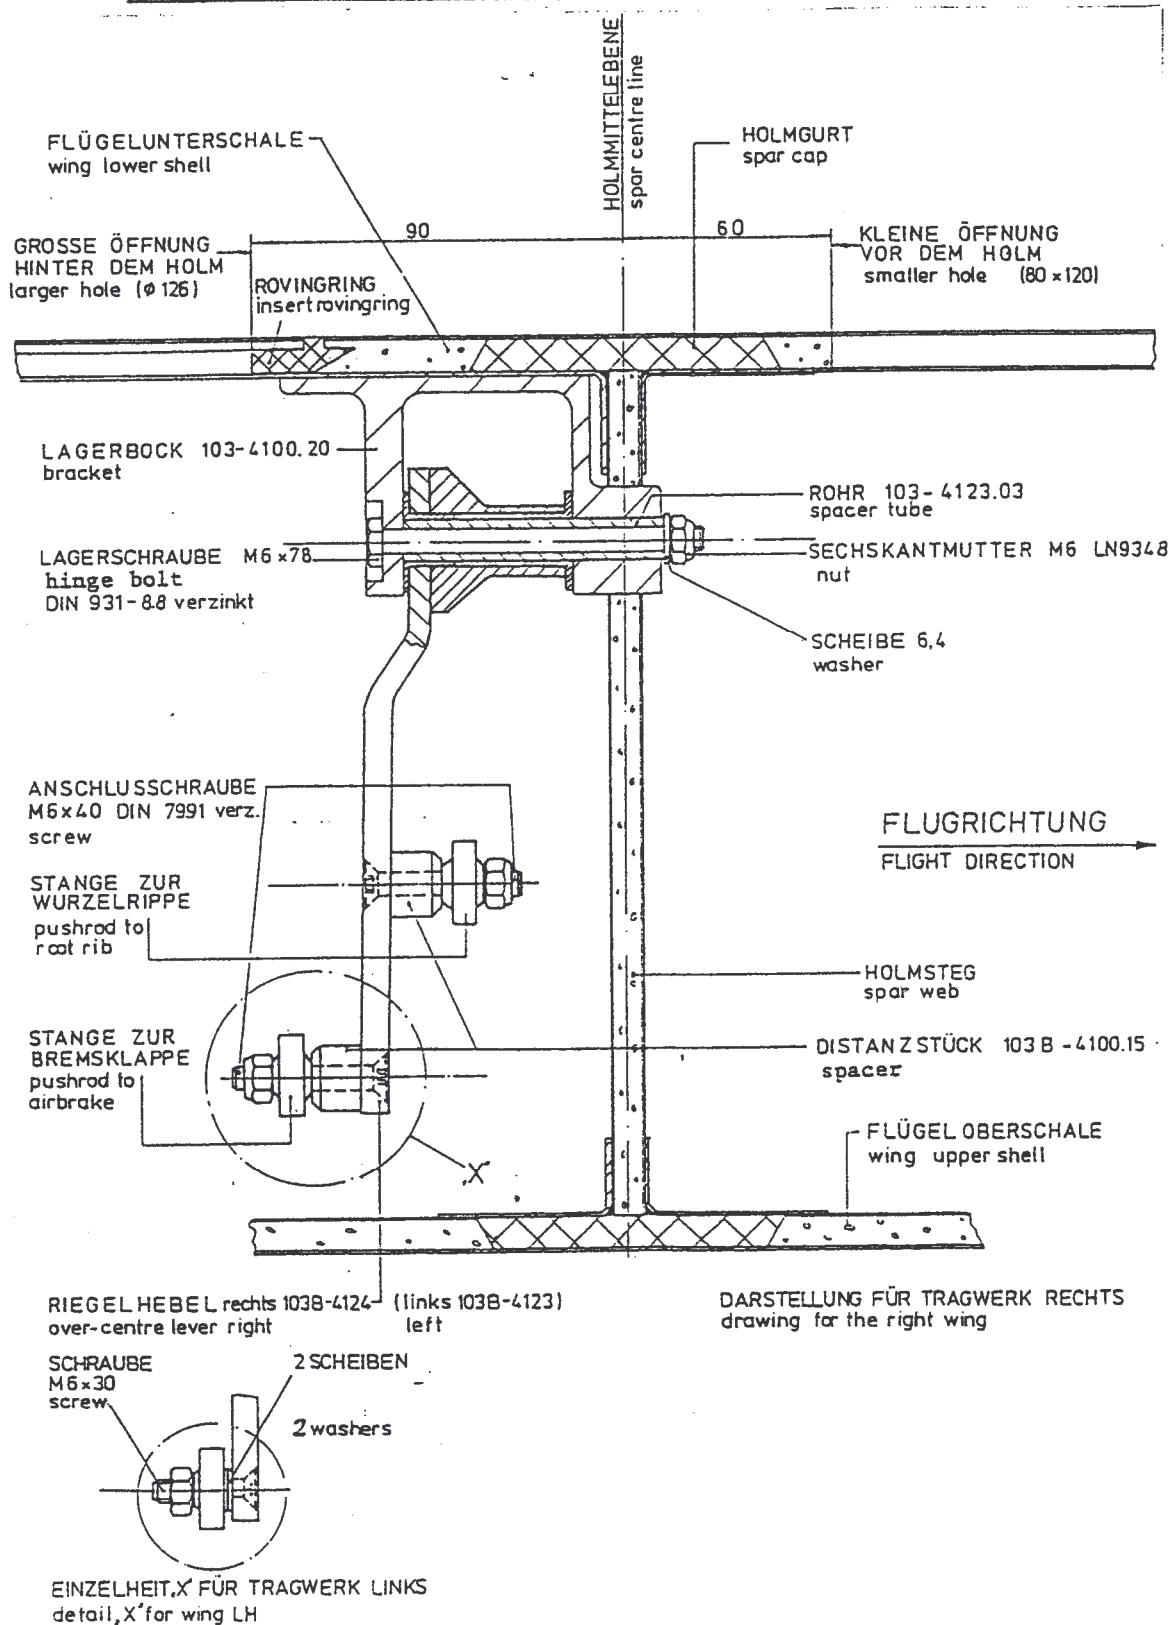
DRAWING 2

Einbau des neuen Riegelhebels Installation of the new airbrake over-centre lever

Remove the hinge bolt through the larger hole. Remove the spacer tube through the smaller edge hole (refer to drawing 2).

12. First attach the control rods in accordance to drawings 2 and 3:

- attach pushrod leading to the root rib to the shorter lever end
 - * in RH wing: with screw M6x40 and spacer 103B-4100.15
 - * in LH wing: with screw M6x40 and spacer 103B-4100.15
- attach pushrod leading to the airbrake to the longer lever end
 - * in RH wing: with screw M6x40 and spacer 103B-4100.15
 - * in LH wing: with screw M6x30 and 2 washers $\phi 6,4$

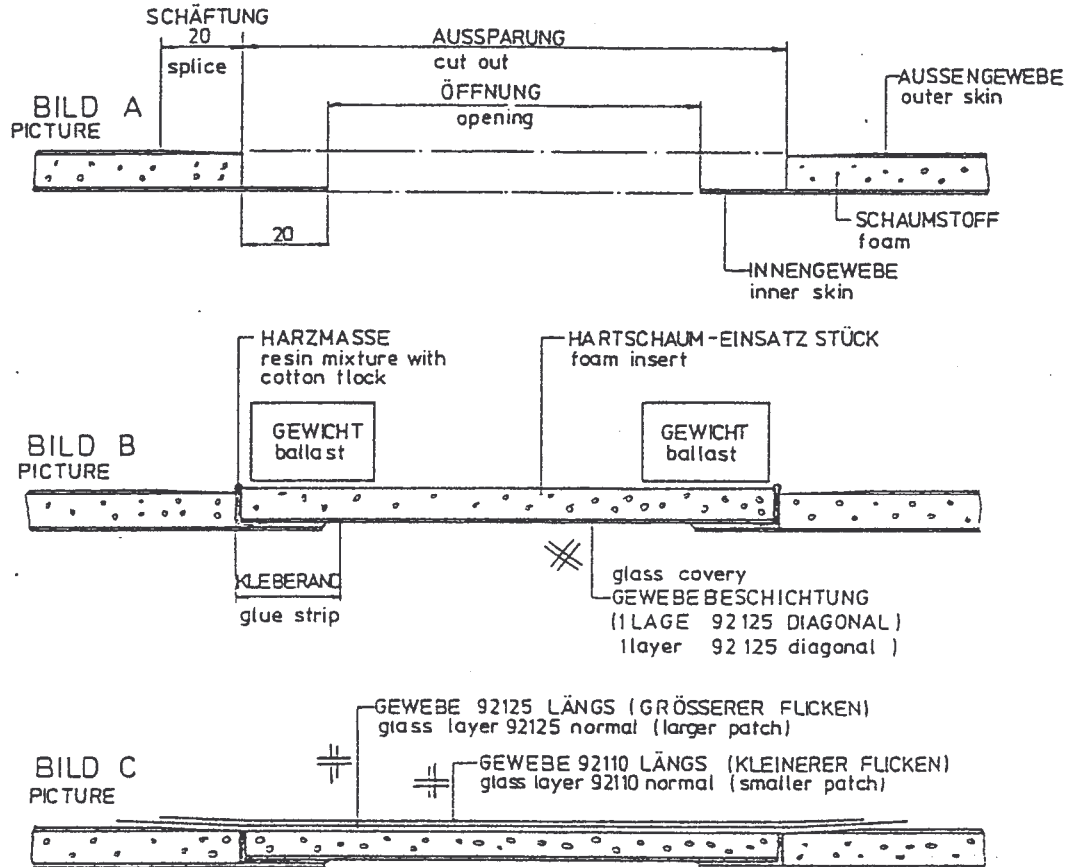
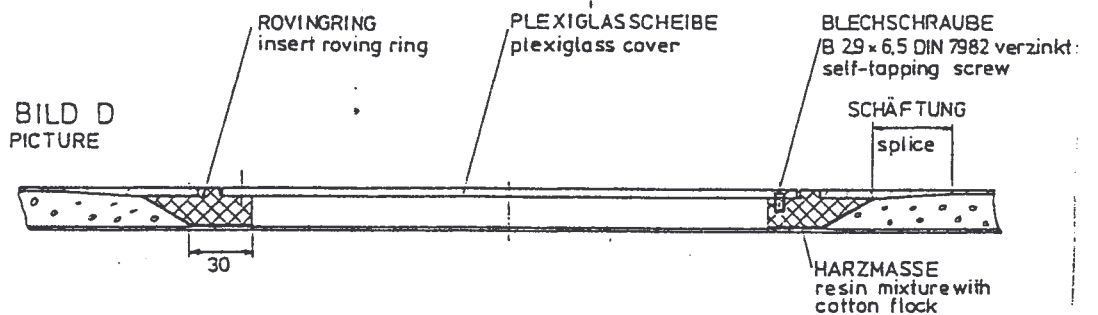
ZEICHNUNG 4
DRAWING 4

Schließen der Flügelschale
Closing of the wing shell

15. Before closing the wing shell in front of the spar, the edges of the opening must be prepared as follows (refer to drawing 4): to enable the inner layer to overlap 20 mm, the outer fabric and the foam must be removed. The size of the opening should be 160 mm x 120 mm, refer to drawing 4, picture A.

16. The foam inserts are supplied oversized and should be installed with the laminated side touching the inner skin.
17. Splice the outer layer 20 mm wide around the cutout using a sanding block. Clean the inner laminate of all foam and carefully grind the area. Also grind the edges of the foam insert (refer to drawing 4, picture A).

19. Mix resin and hardener according to the mixing table and add cotton flocks until a doughy, dripping, sticky mixture is achieved.
20. Apply this mixture to the rim of the inner laminate, and all sides of the foam insert which require glueing. Press the foam insert into the opening (with the laminated side touching the inner skin). Load the foam insert with iron weights to follow the contour of the wing. Fill the gaps between the foam insert and the cut-out with the mixture (refer to drawing 4, picture B).

25. According to drawing 4, picture C, the larger patch of fabric WL 8.4551.60 (Interglas 92125, thicker fabric) is applied first, then the smaller thinner patch WL 8.4548.60 (Interglas 92110) is applied, both patches with the fibre direction parallel to the spar; use a small brush to penetrate the resin.

28. Paint the repaired area.
Note: All grinding and painting work must be performed according to the Repair Instructions in the MM.
29. Install each plexiglass cover 103-1001.48 with 6 self-tapping screws at the insert roving ring (refer to drawing 4, picture D).
