Subject: Extension of operational limitations

Concerned: G 103C TWIN III, S/N's 36001 - 36014

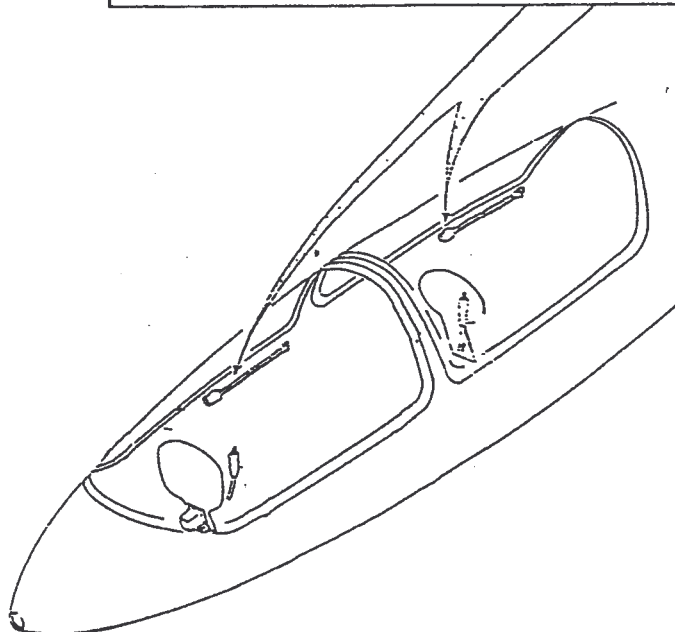
4. b. Installation of the following placard near to the airspeed indicator (1):

Höhe/ Altitude		V _{NE} (IAS)		
[m]	[ft]	[km/h]	[kts]	[mph]
0-2000	0- 6562	260	140	162
-3000	- 9843	247	133	153
-5000	-16404	222	120	138
-7000	-22966	199	107	124
-9000	-29528	178	96	111
