This Service Bulletin substitutes the Service Bulletin 315-61, dated 06 May 1999.

Subject: Inspection/ Replacement of the knurled nut at the rear control stick

Sailplane Model:	TCDS No. 315
G 103 TWIN II	S/N 3501, - 3729
G 103A TWIN II ACRO	S/N 3501 - 3729 (with suffix "K")

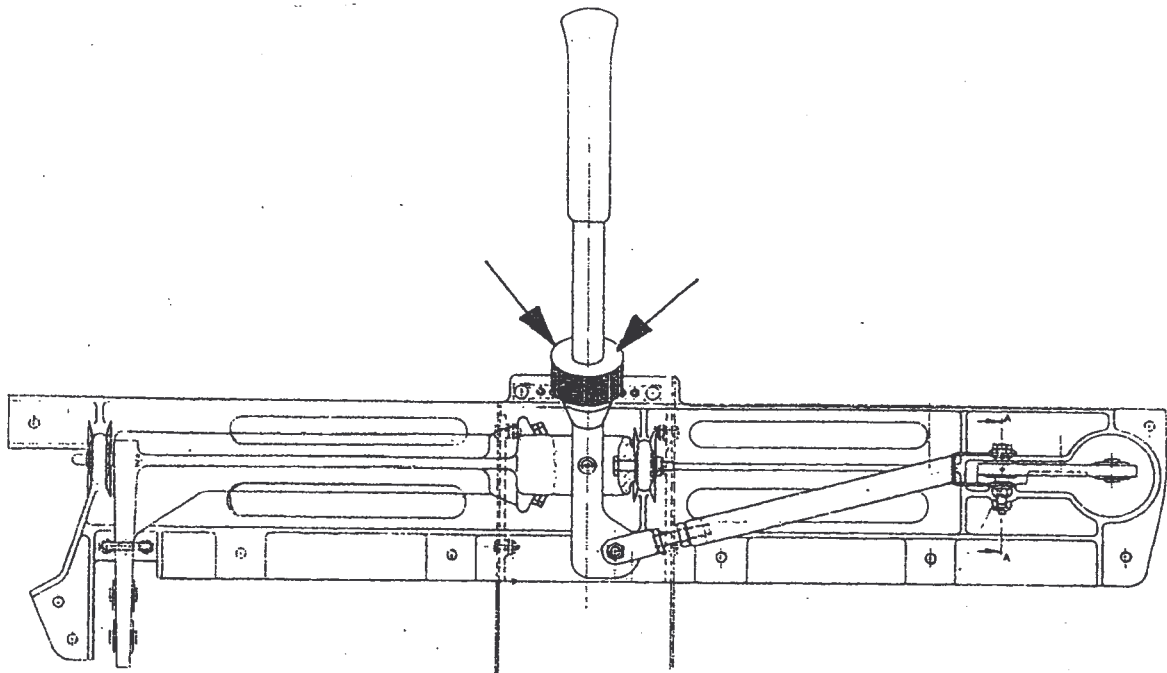
Single cases had been reported to GROB, where the fastening nut (knurled nut) was cracked. Previous investigations showed, that these damages may be caused by improper handling i.e. fastening the nut too tight. As a precautionary action an inspection or replacement of the knurled nut is mandatory.

1. The knurled nut must be checked for damage, especially for cracks on the upper side of the nut. **If the nut is found damaged or cracked, the nut must be replaced immediately.**

2. The inspection must be repeated before the first flight of a day, until the knurled nut is replaced.
3. The knurled nut at the rear control stick must be replaced for a new knurled nut made from stainless steel.

Material: The new knurled P/N 103-4205.03/2 is attached to the Service Bulletin.

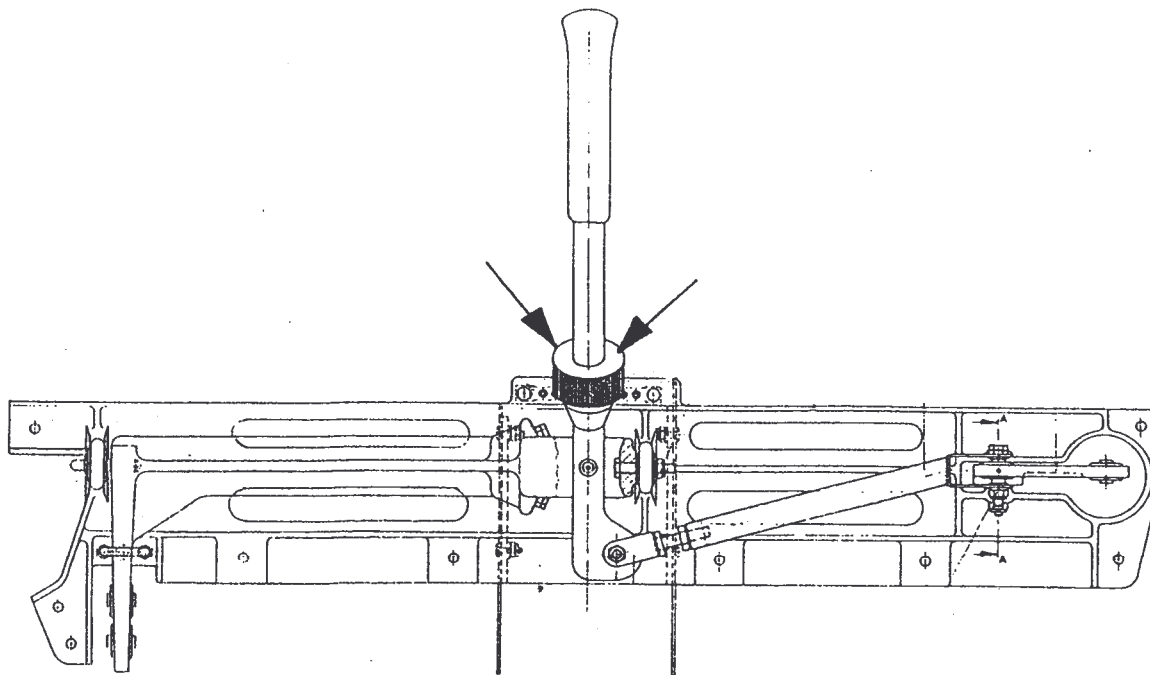
Background Information: Single cases had been reported to GROB, where the fastening nut (knurled nut) was cracked. Previous investigations showed, that these damages may be caused by improper handling i.e. fastening the nut too tight. As a precautionary action an inspection or replacement of the knurled nut is mandatory.

1. The knurled nut must be checked for damage, especially for cracks on the upper side of the nut. **If the nut is found damaged or cracked, the nut must be replaced immediately.**

2. The inspection must be repeated before the first flight of a day, until the knurled nut is replaced.
3. The knurled nut at the rear control stick must be replaced for a new knurled nut made from stainless steel.

Material: The new knurled P/N 103-4205.03/2 is attached to the Service Bulletin.
