## ALERT SERVICE BULLETIN NO. ASB315-64/2

#### 1.4 Subject:

Limitations of Operation

TWIN ASTIR  
TWIN ASTIR TRAINER

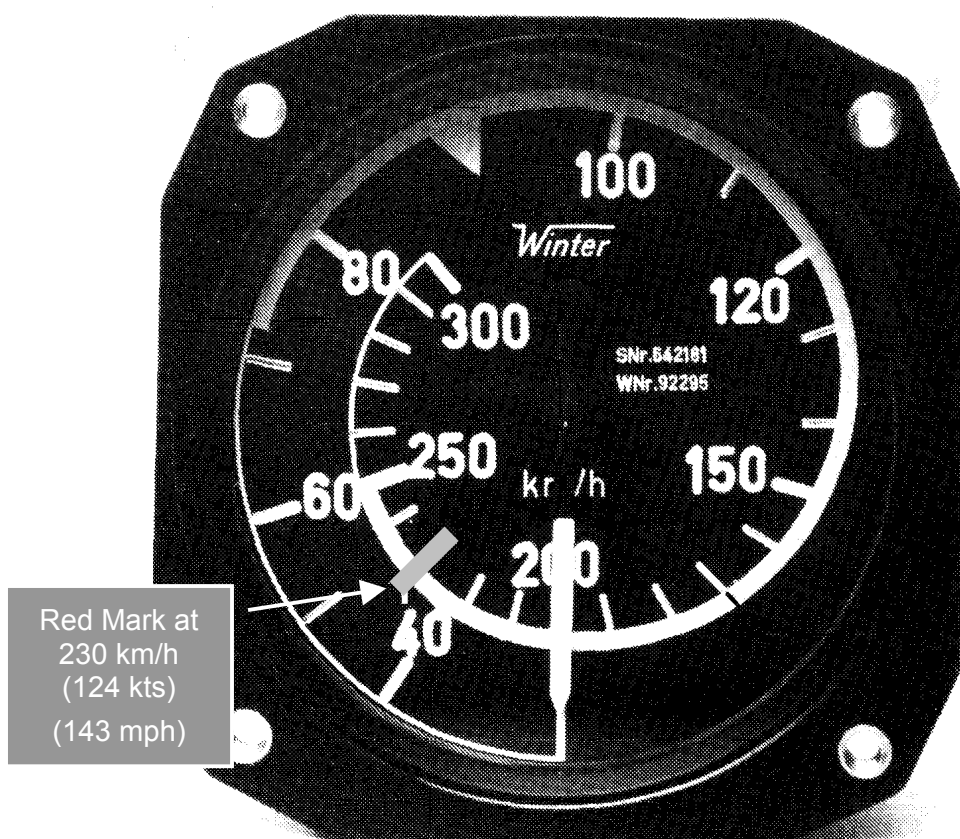
New investigations of the fuselage structure of TWIN III Acro have indicated, that the safety margins against damage of the fuselage structure under limit loads might be insufficient. The flight envelope for TWIN II and TWIN III has already been restricted under ASB 315-63.

The structure design and the flight loads of TWIN ASTIR and TWIN ASTIR TRAINER are similar. Therefore, the speed for rough air  $v_B$ , the maximum speed in calm air  $v_{NE}$  and as a consequence of that the maximum speed with airbrakes extended  $v_{DF}$  is reduced for these models as well.

The maximum speed in rough air is reduced to  $v_B = 170$  km/h (92 kts / 105 mph). The maximum speed in calm air and as a consequence of that the maximum speed with airbrakes extended are reduced to  $v_{NE} = v_{DF} = 230$  km/h (124 kts / 143 mph). The following must be performed for that:

1. Apply a red mark to the front and the rear airspeed indicator at **230 km/h (124 kts / 143 mph)**:

**NOTE:** The markings are attached to this Service Bulletin.
