Subject: Inspection and reinforcement of welded parts in the flight control system of the gliders GROB G 103 TWIN II and G 103 A TWIN II ACRO. The following welded parts will be reinforced:

Service Bulletin  
TM 315-37

GROB  
G 103 TWIN II  
G 103 A TWIN  
II ACRO

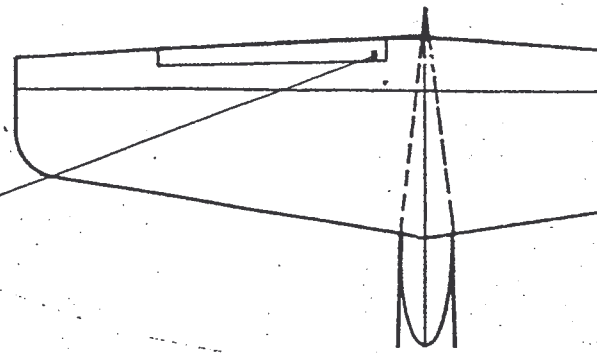
Die in unten abgebildeter Übersichtszeichnung markierten Steuerungsteile sind auf Anrisse und Verformungen zu überprüfen.
